Sediment Transport during Drawdown of the Copco 1 Reservoir on the Klamath River under Dam Removal Scenarios

Yong G. Lai and Blair P. Greimann
Technical Service Center

U.S. Department of the Interior
Bureau of Reclamation

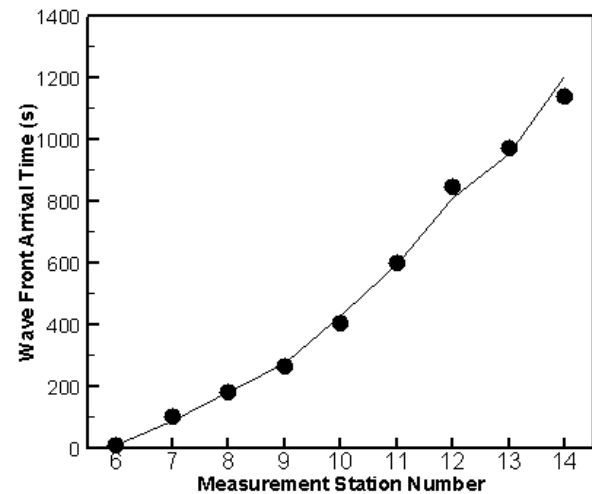
Malpasset Dam Break Modeling

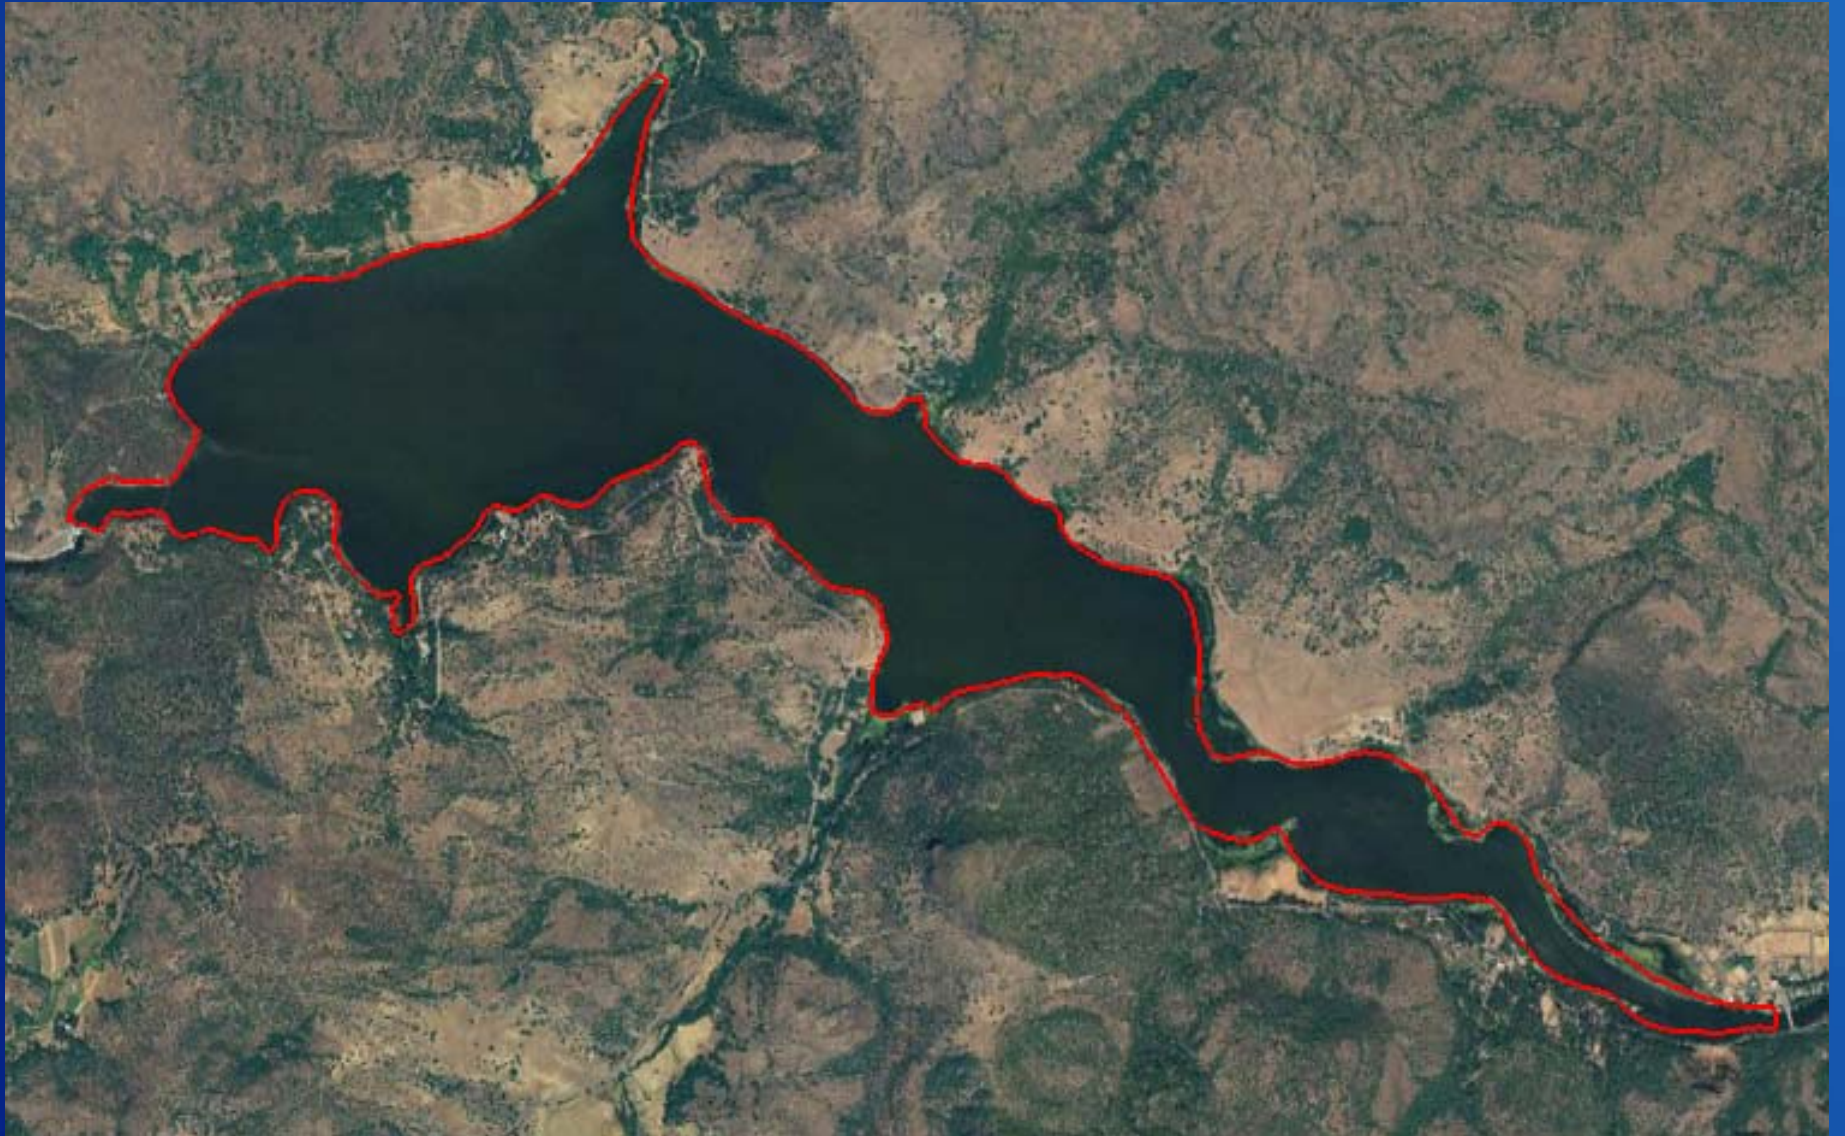
Solution Domain (~ 4 miles)

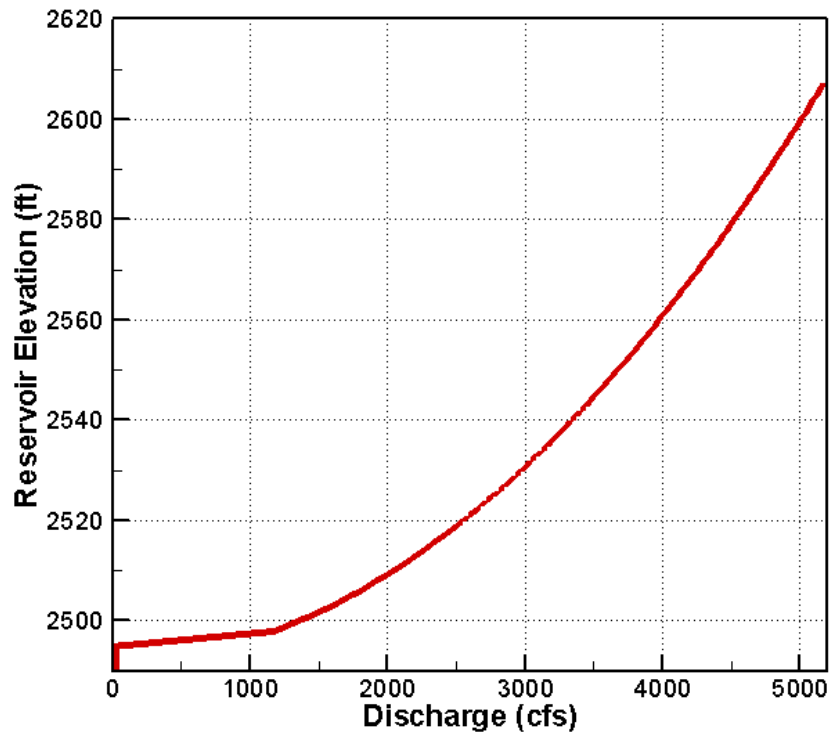
Discharge Capacity

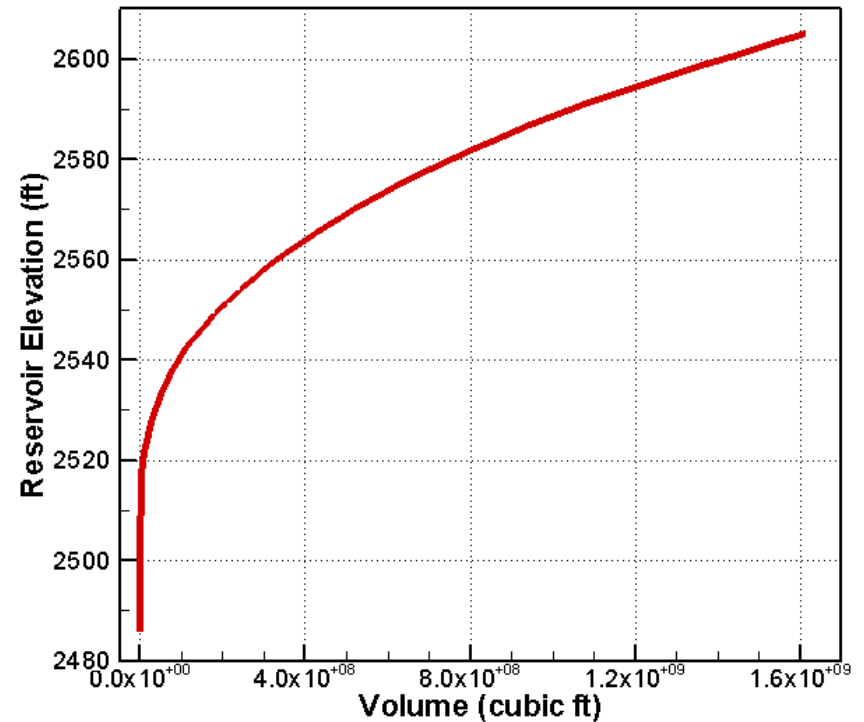
Storage Capacity

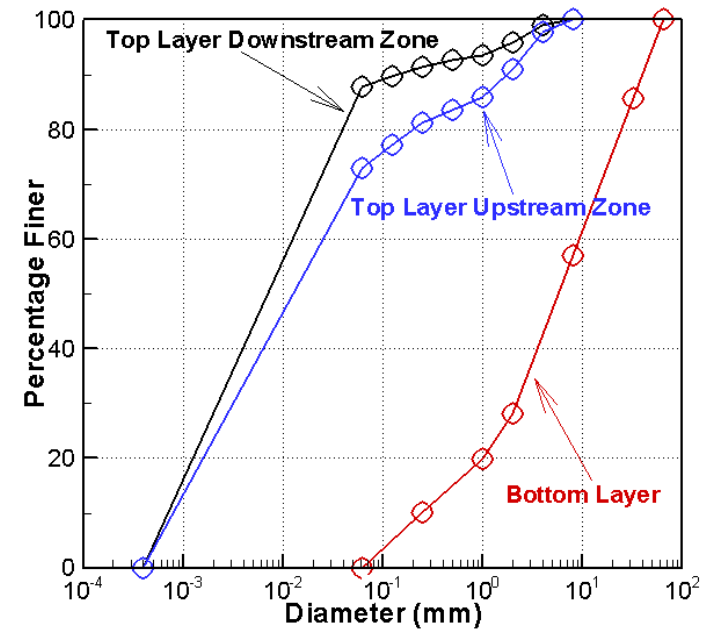
Sediment Size Classes

Sediment Size Class	(mm)
1	Cohesi
2	.0625 to
3	.125 to
4	.5 to
5	2 to 8
6	8 to 3
7	32 to 125

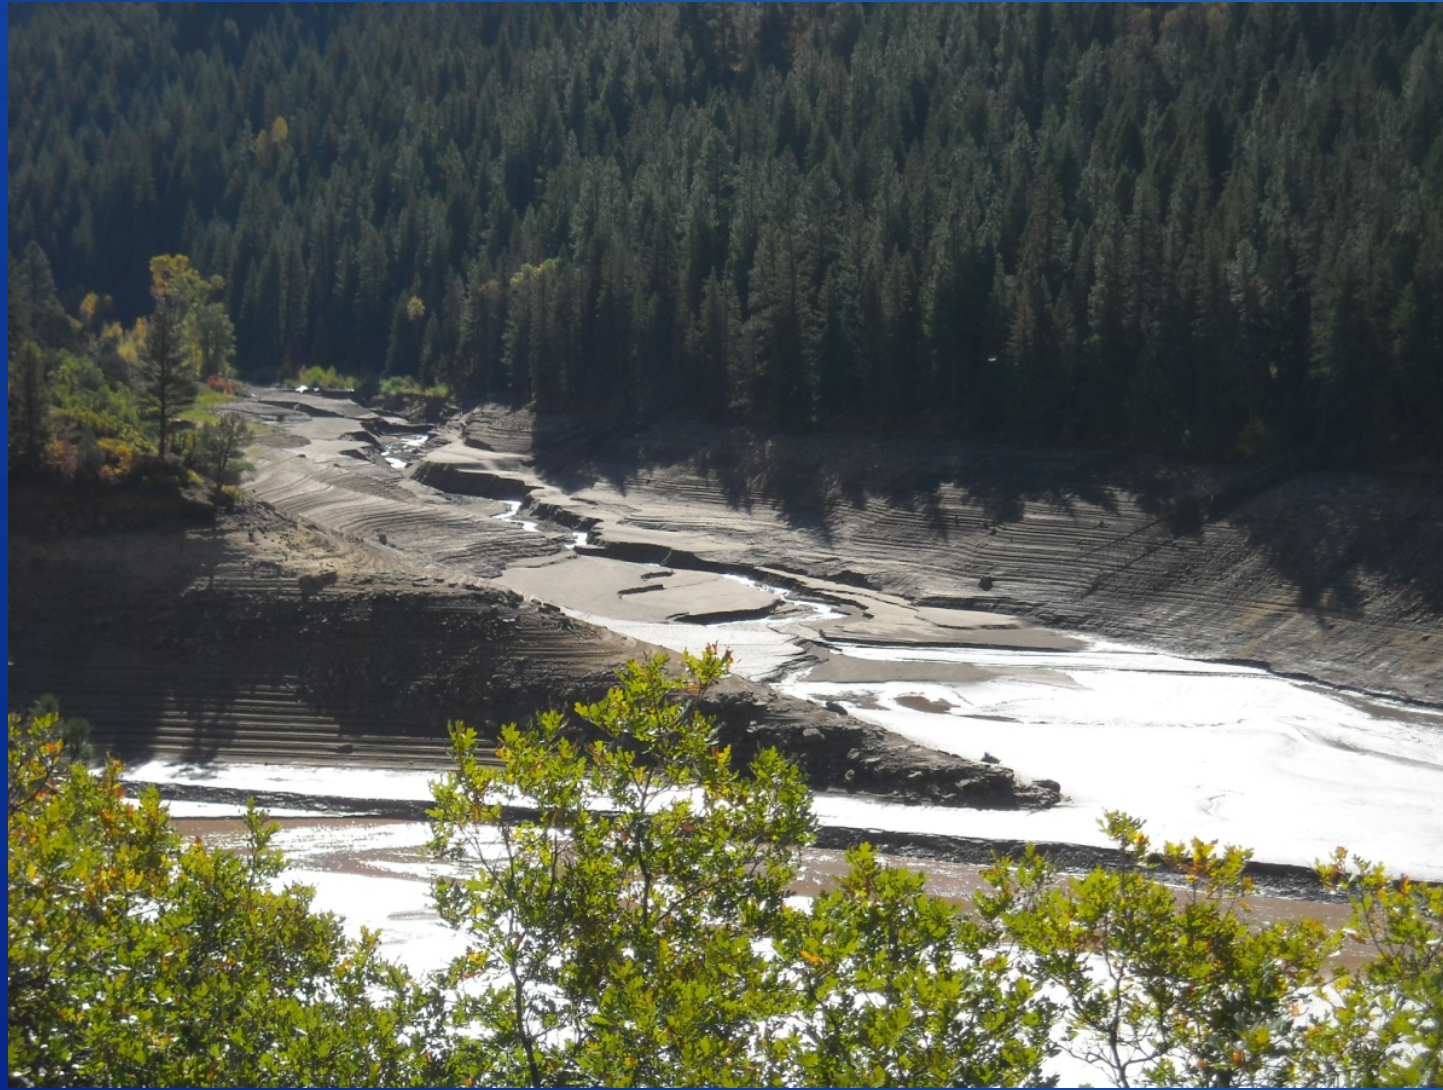
Typical Channel Incision through Reservoir Sediments due to Reservoir Drawn-Down (Paonia Reservoir in Colorado)

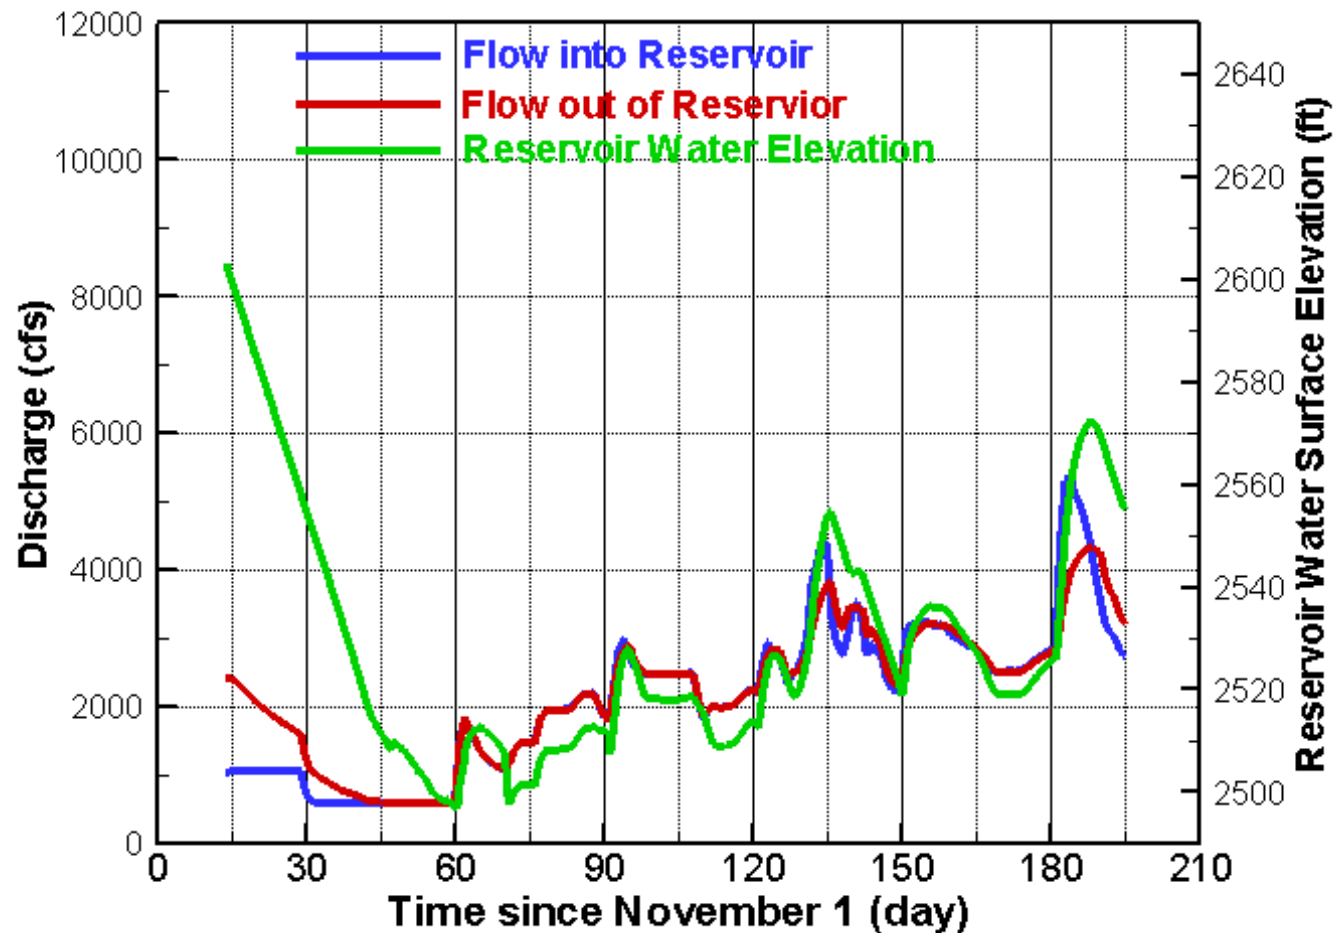
Predicted Reservoir Water Elevation and Flow Exiting the Reservoir

(average year; medium-erode)

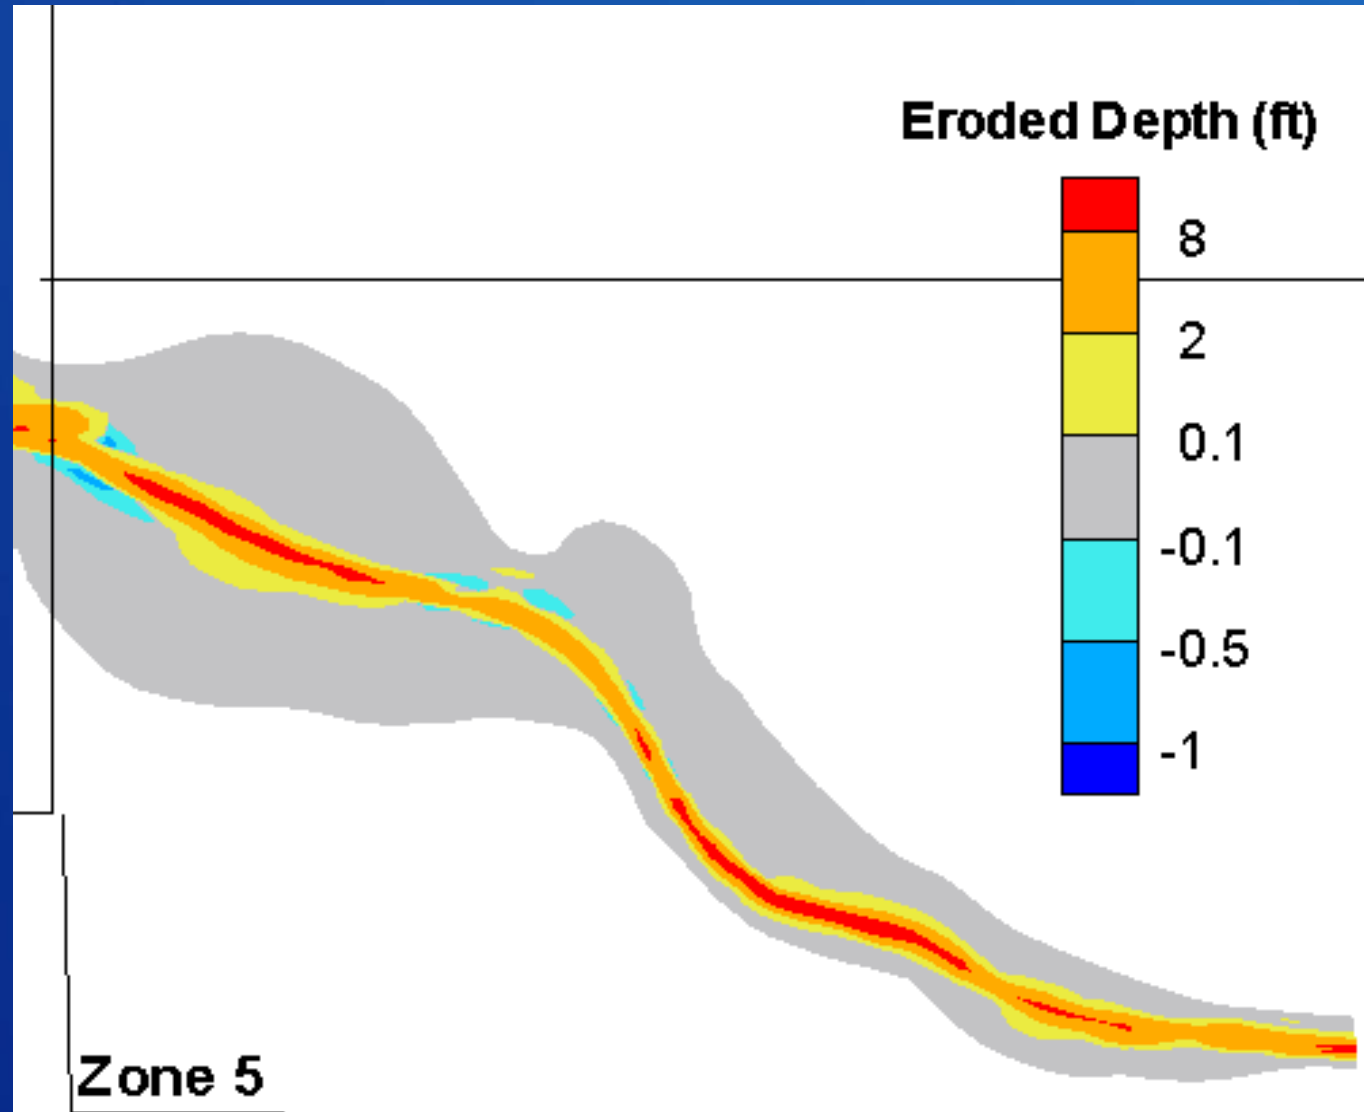
Erosion/Deposition Pattern: Zonal View (average year)

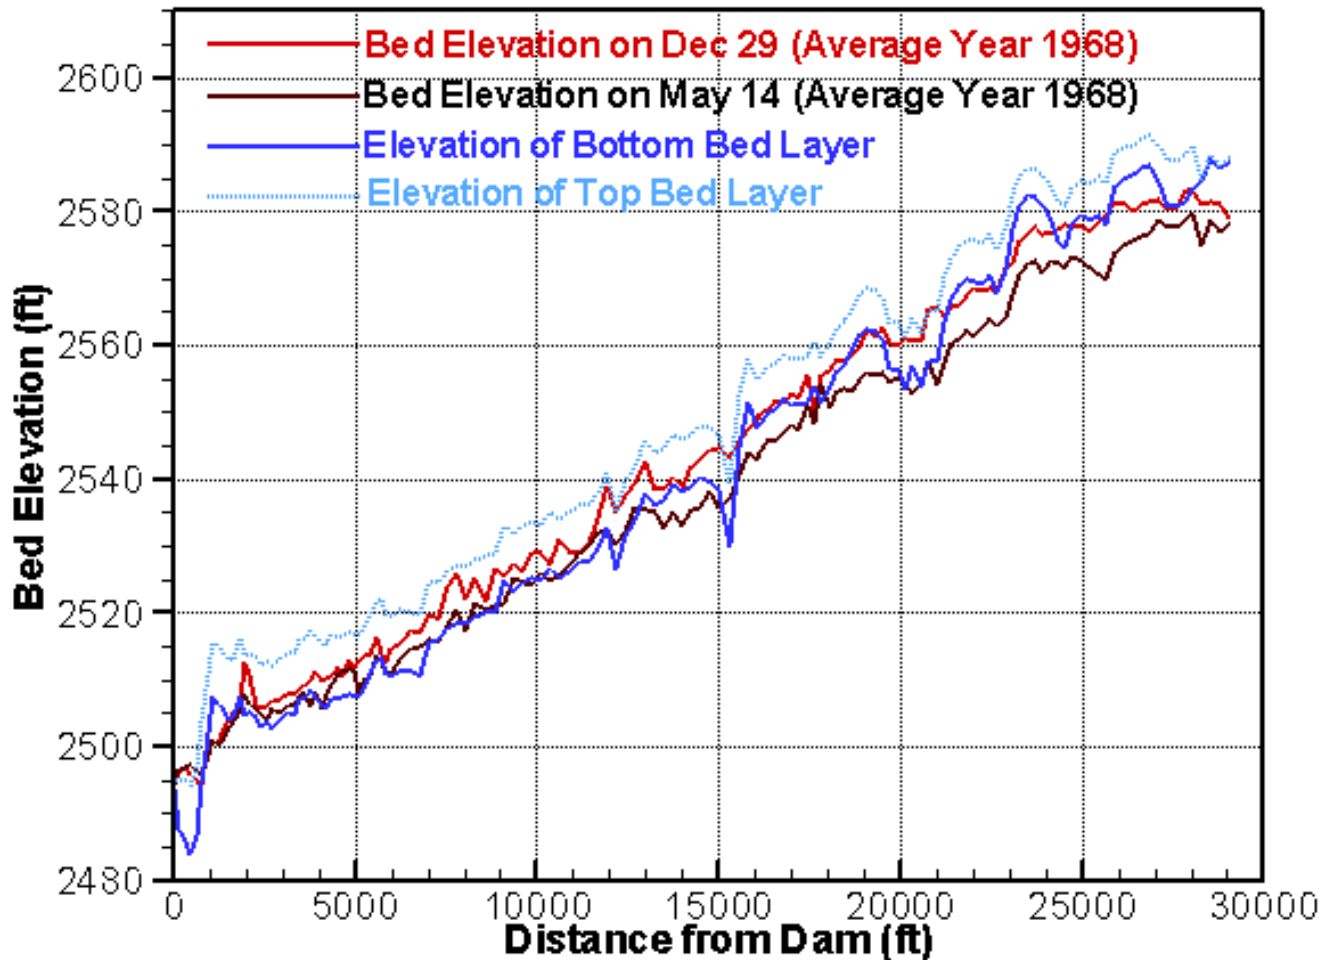
Predicted Bed Elevation along Thalweg (average year)

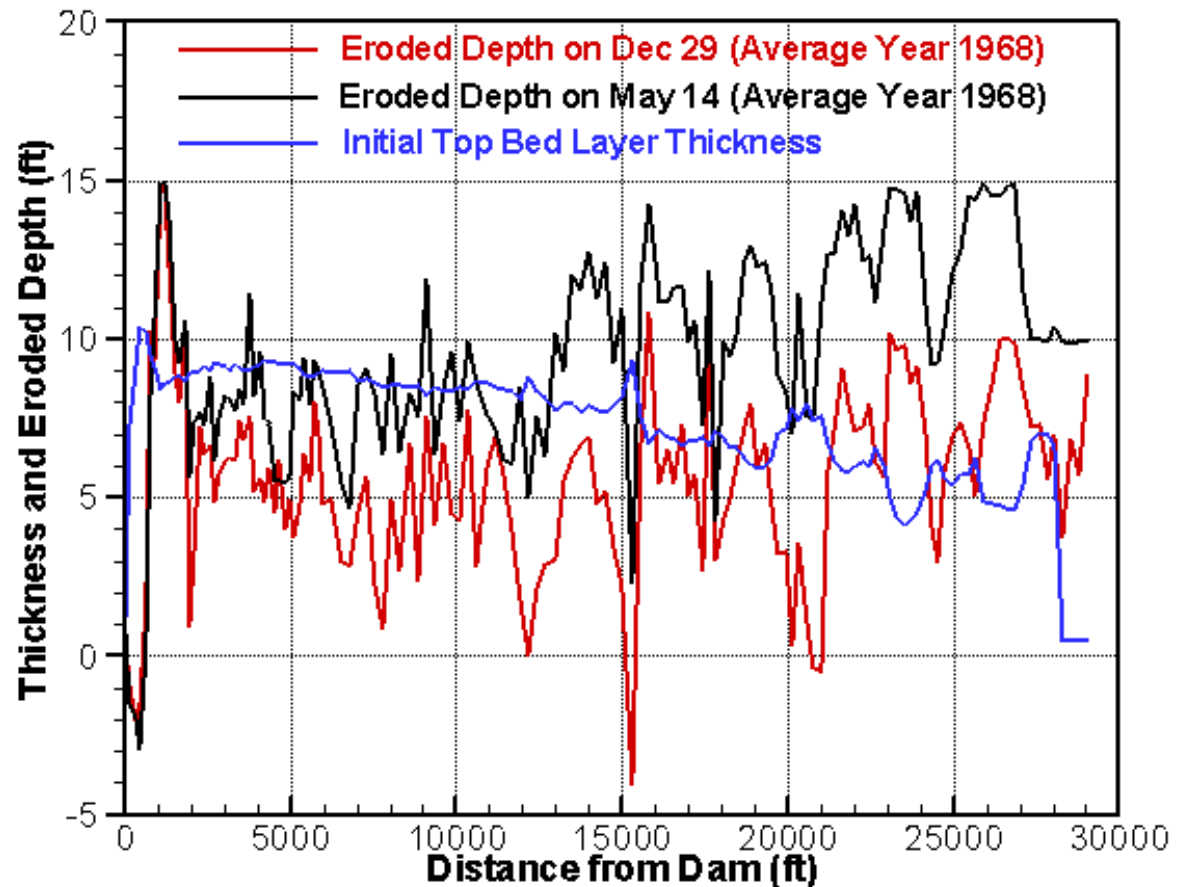
Eroded Depth along Thalweg Compared with Initial Top Layer Thickness (average year)

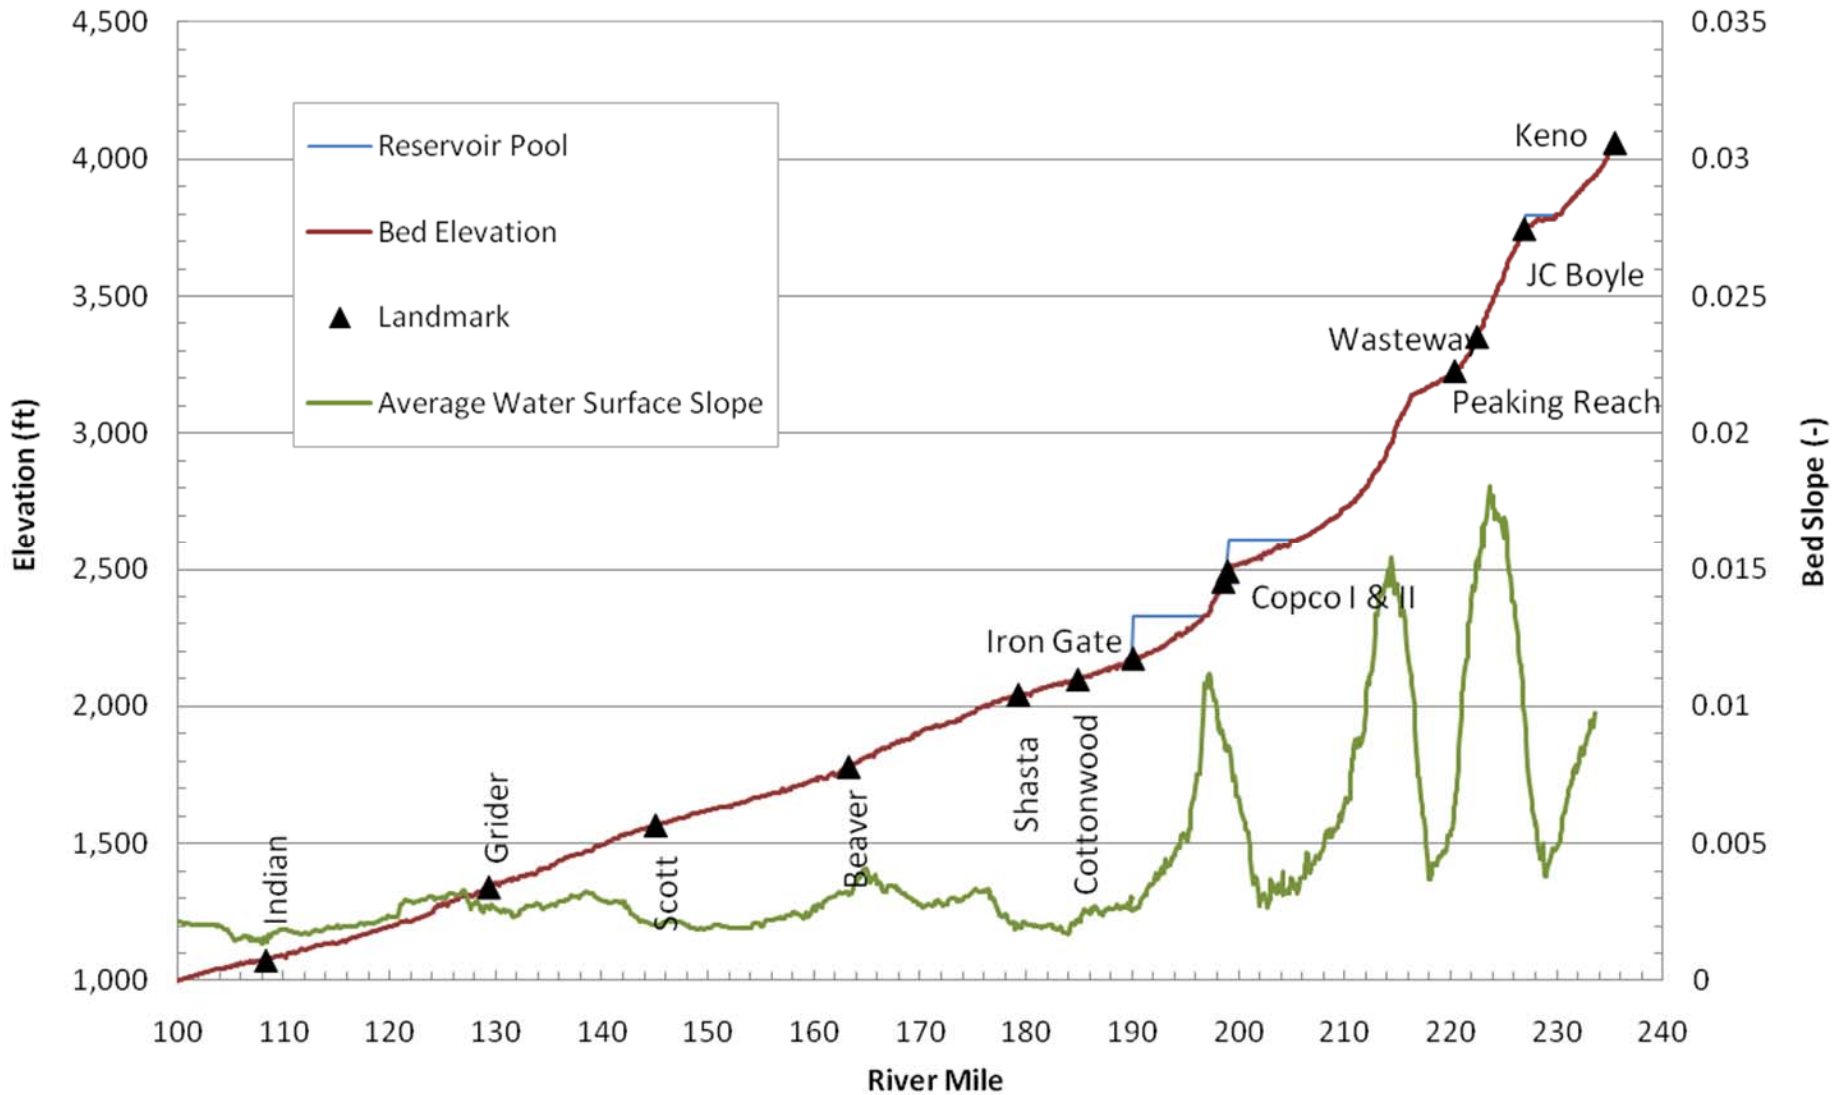
Bed Elevation Profile
